DEPARTMENT OF THE NAVY  
COMMANDER EXPEDITIONARY STRIKE GROUP THREE  
NAVAL BASE SAN DIEGO, BLDG 73  
3205 SENN ROAD  
SAN DIEGO CA 92136-5090

Subj: COMMAND INVESTIGATION INTO THE MAIN REDUCTION GEAR CASUALTY  
THAT OCCURRED ONBOARD USS BOXER (LHD 4) ON 11 JULY 2023

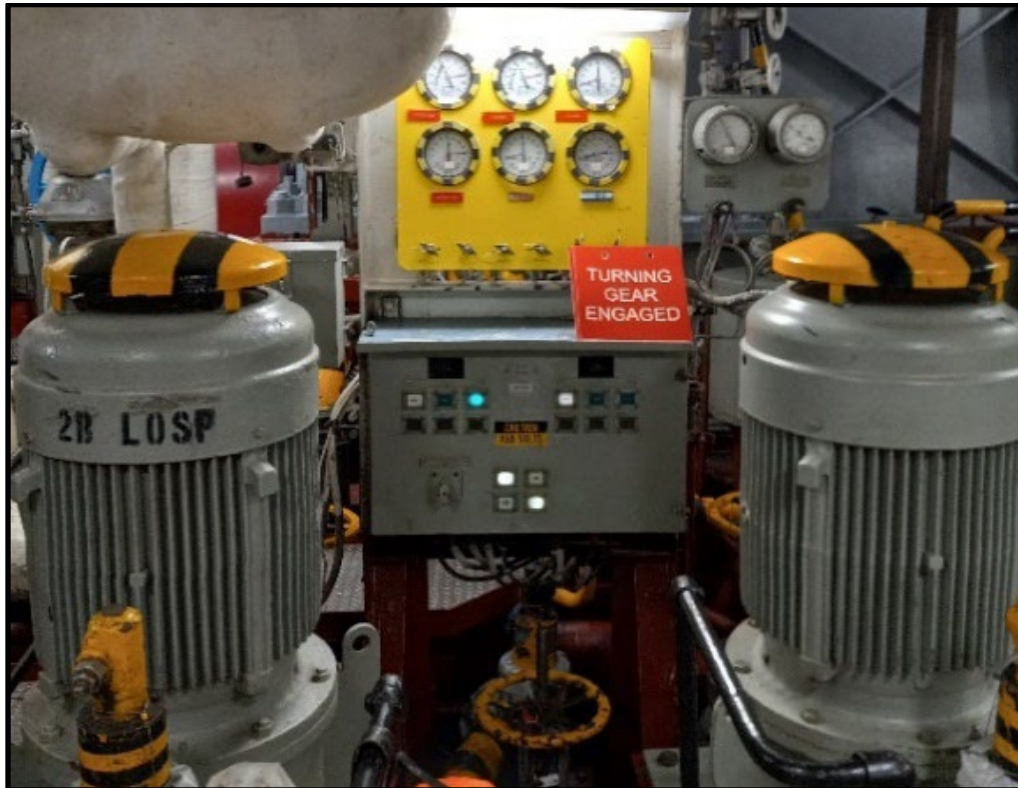
6. BOX is fitted with two lube oil service pumps (LOSPs) per MRG. The Main LO pumping units consist of a pump and an alternating current motor driver which are flexibly coupled. The pump is a positive displacement, vertically mounted screw pump. The two LOSPs in FWD MMR are labelled 2A and 2B LOSP. [Ref (f)]

Figure 3 – FWD MMR Main LOSP 2A & 2B
